**AFRL-RQ-WP-TM-2016-0155**

# **OPERATION OF A T63 TURBINE ENGINE USING F24 CONTAMINATED SKYDROL 5 HYDRAULIC FLUID**

**SEPTEMBER 2016**

**Interim Report**

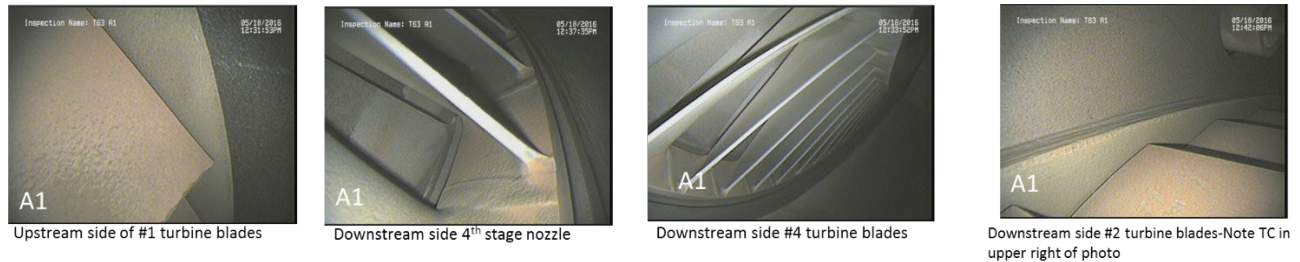
Figure 4. Turbine Section Component Borescope Photos

The engine was reassembled with a plastic media blasted clean combustor liner, first stage heat shield, and ultrasonically cleaned fuel nozzle depicted in Figure 2. The inspection included photo documentation of the first stage nozzle and #1 turbine condition from the rear of the engine with the combustion liner removed shown in Figure 3. Additional inspections of the second stage nozzle, #2 turbine, and third stage nozzle were carried out by removing combustor thermocouple and using a borescope depicted in Figures 4 and 5. The #4 turbine and fourth stage nozzle were accessed through the exhaust ports of the engine with the borescope Figures 4 and 5. SEM results indicated the first stage nozzle was comprised of 49.2% (wt.) cobalt.

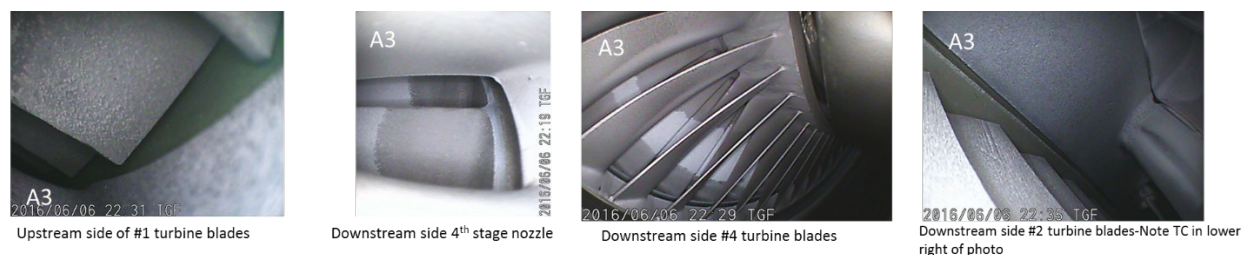
Figure 17. Turbine Section Component Borescope Photos after Operating on 1% Skydrol 5 with F-24 for Fuel for 25 hours

The inspection continued with the examination of the first stage nozzle condition after the removal of the combustor liner and first stage heat shield. The condition of the first stage nozzle can be observed in Figure 11. The first stage nozzle did not exhibit any cracks and the number eight bearing cover remained a shade of green as seen earlier when operated on the 5% Skydrol concentration fuel. Upon closer examination of the first stage nozzle a color change was observed resulting in a pinkish purple hue coating the nozzle surface with washed out white patches. The washed out areas were also observed as seen in Figure 17 when inspecting the turbine section surfaces with a borescope through the thermocouple mounting port and behind the first stage nozzle on the #1 turbine. These surface color changes continued through the rest of the turbine section inspection observed in Figure 18
